RUNWAY OVERRUN DURING LANDING
AMERICAN AIRLINES FLIGHT 1420
MCDONNELL DOUGLAS MD-82, N215AA
LITTLE ROCK, ARKANSAS
JUNE 1, 1999

Aircraft Accident Report

**Runway Overrun During Landing
American Airlines Flight 1420
McDonnell Douglas MD-82, N215AA
Little Rock, Arkansas
June 1, 1999**

**NTSB/AAR-01/02
PB2001-910402
Notation 7195A
Adopted October 23, 2001**

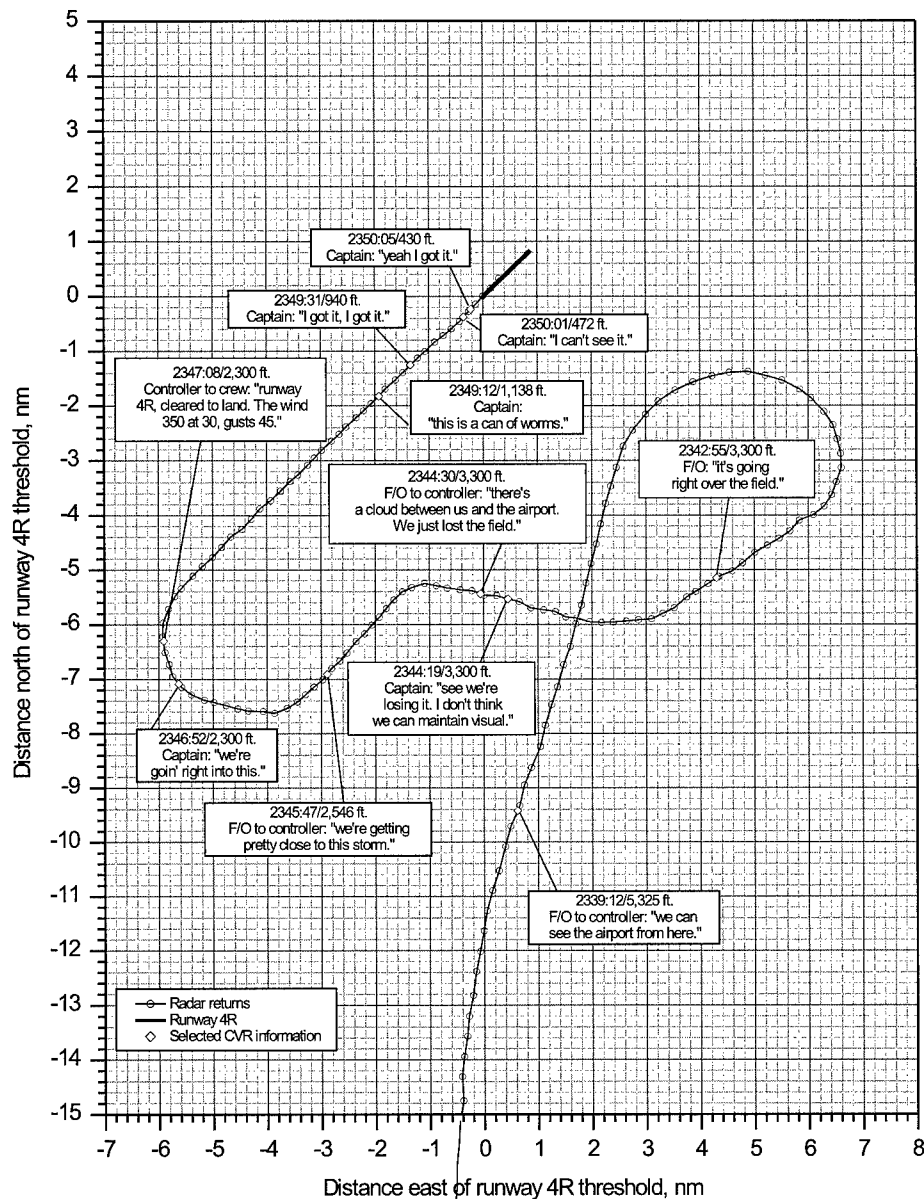
Figure 1. Flight 1420's Approach Path to the Airport and Key CVR Comments

The CVR indicated that, at 2350:00, the first officer said, "we're way off." Flight data recorder (FDR) information indicated that the localizer deviation value was about one dot to the right at that point.¹⁸ About 1 second later, the captain stated, "I can't see it." About 3 seconds afterward, the first officer asked, "got it?" to which the captain replied, "yeah I got it." At 2350:13 and :14, the CVR recorded the sound of the ground proximity warning system (GPWS) radio altitude callout "sink rate."¹⁹ Calculations based on FDR data indicated that the airplane was descending through an altitude of about 70 feet afl at the time of the first sink rate warning and about 50 feet afl at the time of the second warning. Figure 1 shows flight 1420's flightpath to Little Rock and runway 4R along with key CVR comments and the airplane's location when the comments were made.

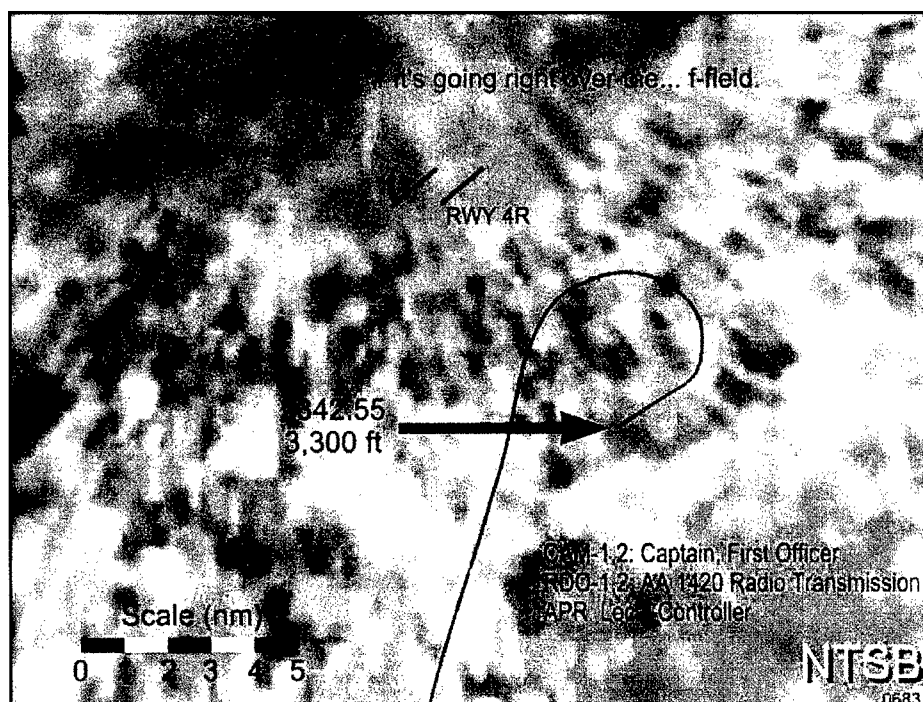
Figure 20. Weather and Flight Information for 2342:55

The flight crew continued to receive, but did not discuss, wind reports from the controller. The flight crew's actions and conversations during this phase of the approach largely consisted of steps to expedite the approach to the airport. For example, at 2342:40, the first officer asked the captain if he wanted to conduct a "short approach" and "keep it in tight." The captain accepted the suggestion but with the qualification "if you see the runway, 'cause I don't quite see it." (The airport was off the right, or first officer's, side of the airplane.) The first officer began to radio the controller at 2342:54 to suggest a visual approach but interrupted this transmission 1 second later when he stated to the captain, "it's going right over the...field." In a postaccident interview, the first officer indicated that he was referring to a temporary obstruction of his view of the airport because of clouds. The first officer's next transmission, 4 seconds later, informed the controller that "we got the airport" and that "we're going between clouds." Figure 20 shows a map of the weather conditions at 2342:55 and flight 1420's location.

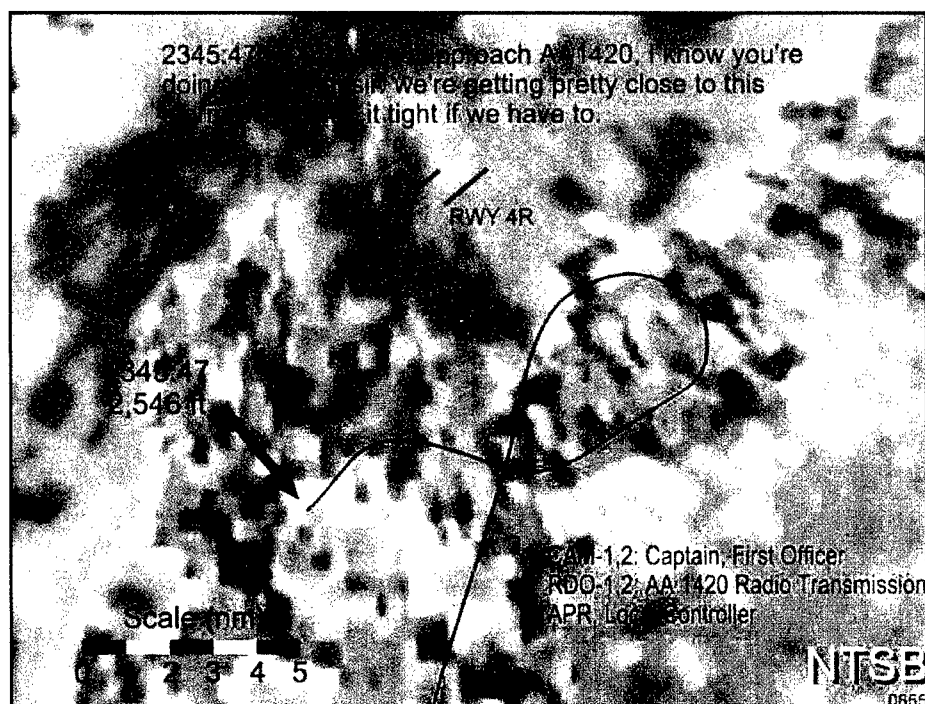
Figure 22. Weather and Flight Information for 2345:47

The weather south of the airport became the next focus of the flight crew's attention. NWS radar data indicated that, in the 6 minutes before the accident, a line of thunderstorms, with several large areas of intense and extreme activity, was encompassing the Little Rock airport area and runway 4R approach path. At 2345:47, the first officer told the controller "we're getting pretty close to this storm. we'll keep it tight if we have to." The controller indicated to the flight crew that, "when you join the final, you're going to be right at just a little bit outside the marker if that's gonna be okay for ya." The captain stated, "that's great," and the first officer told the controller, "that's great with us." Figure 22 shows a map of the weather conditions at 2345:47 and flight 1420's location.
